HOLY LOCH FLEET MOORINGS INSPECTION REPORT(U) NAVAL  
FACILITIES ENGINEERING COMMAND WASHINGTON DC CHESAPEAKE  
DIV 15 OCT 82 CHES/NAVFAC-FPO-1-82(22)

HOLY LOCH  
FLEET MOORINGS  
INSPECTION REPORT

FPO-1-82(22)

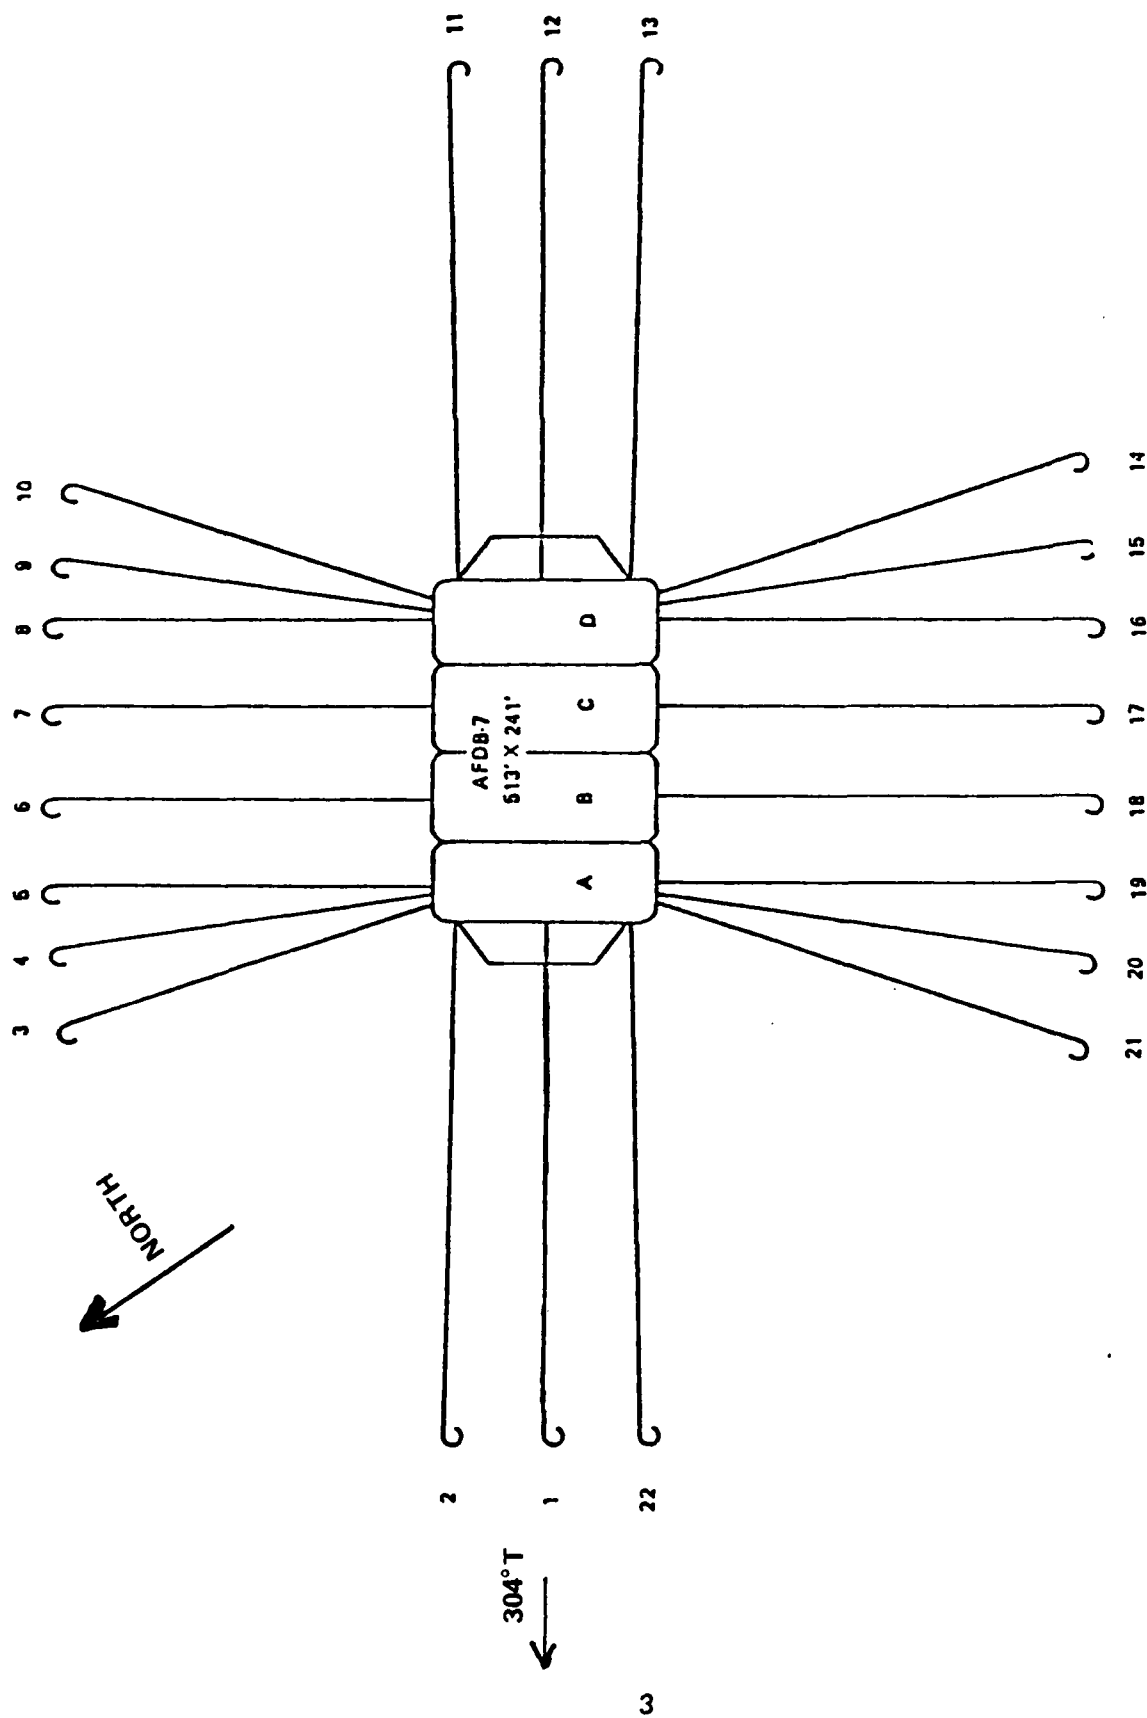
Figure 2. Schematic of AFD8-7 Mooring, Showing Ground Leg Numbers

The dry dock is routinely used by fleet ballistic missile (FBM) submarines. Because of the strategic importance of this facility and the possibility of severe winter weather, the material condition of the mooring is a continuing concern. Between 1973 and 1981, 19 of the 22 ground legs were inspected by the British Ministry of Defense (M.O.D.). During this period, only one of the ground legs was determined to contain a chain link which has worn to less than 80% of the original wire diameter; the length which contained this link was replaced in 1981. In April 1982, divers from USS HUNLEY (AS-31) visually inspected 21 of the 22 ground legs. All chain was reported to be in good condition, although some legs were observed to have little or no catenary.

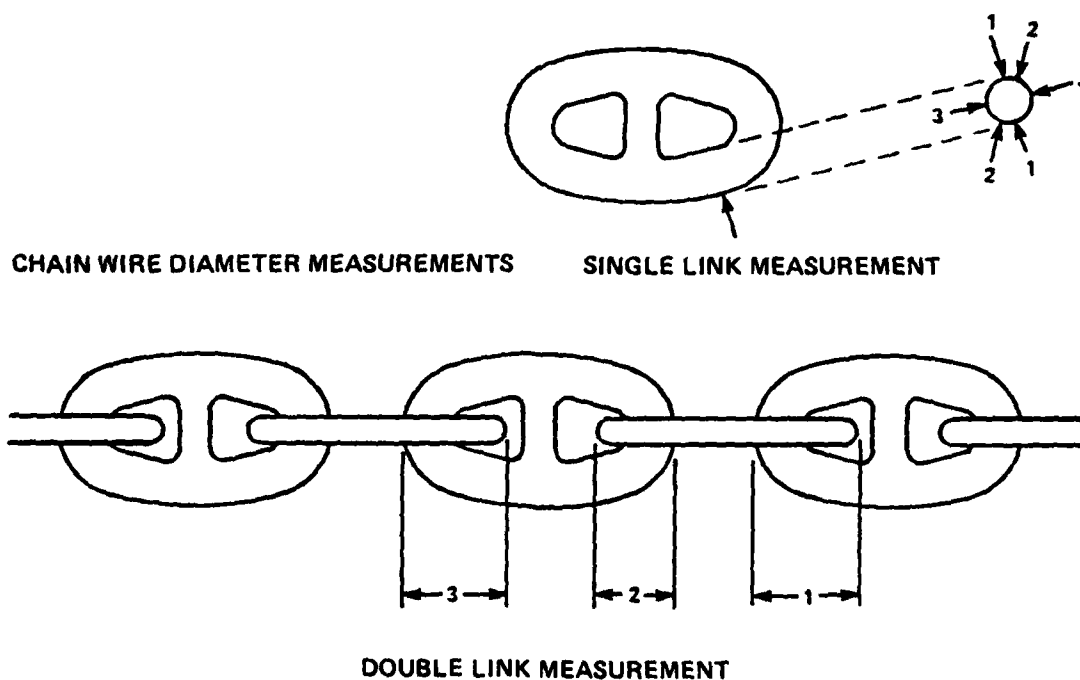
Figure 4. Chain Wire Diameter Measurements and Ground Leg Catenary Observations

**2.1.3 Catenary Profile.** Several observations were made in order to determine the catenary of each leg. The parameters involved are illustrated in Figure 4. The inclinometer readings were taken where the chain enters the water; depth readings were taken directly below the deck edge and where the chain enters the

mud; the lateral distance is the horizontal distance from the deck edge to the pop float installed above the position where the chain enters the mud. Two inclinometer readings were taken on several legs: the first under relatively calm conditions (winds less than 10 KTS), and a second during strong winds (to 40 KTS) in order to compare the effect on the catenary.

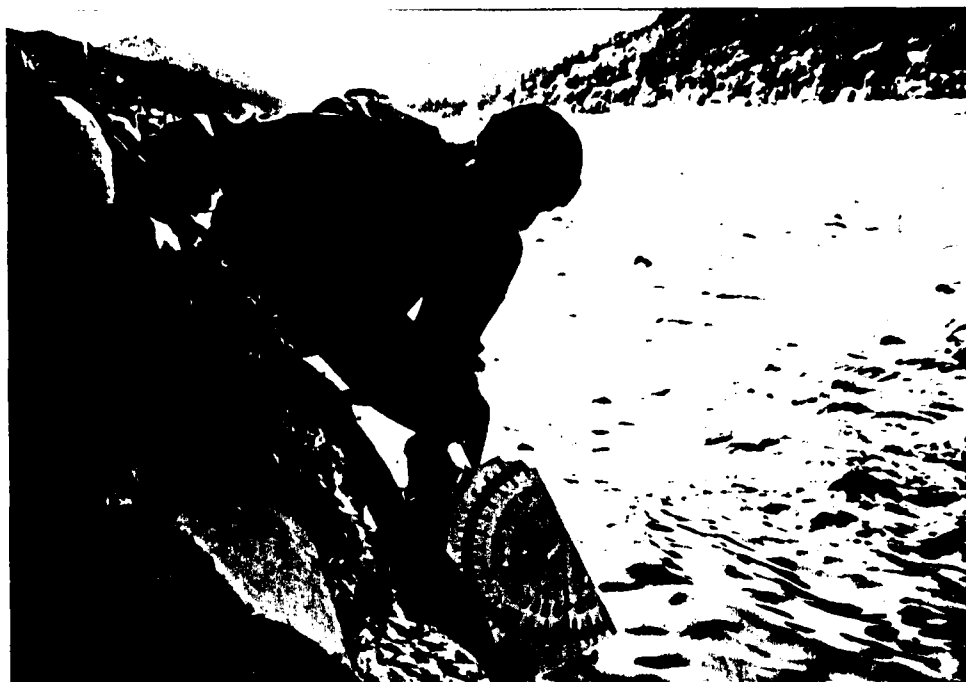
Using inclinometer to measure angle of anchor leg.
